HOSKINS-WESTERN-SONDEREGGER INC LINCOLN NE
NATIONAL DAM SAFETY PROGRAM. NODAWAY LAKE DAM (MO 10178) LOWER --ETC(U)
AUG 78 H P HOSKINS

PHASE I INSPECTION REPORT
NATIONAL DAM SAFETY PROGRAM

PHASE I REPORT
NATIONAL DAM SAFETY PROGRAM

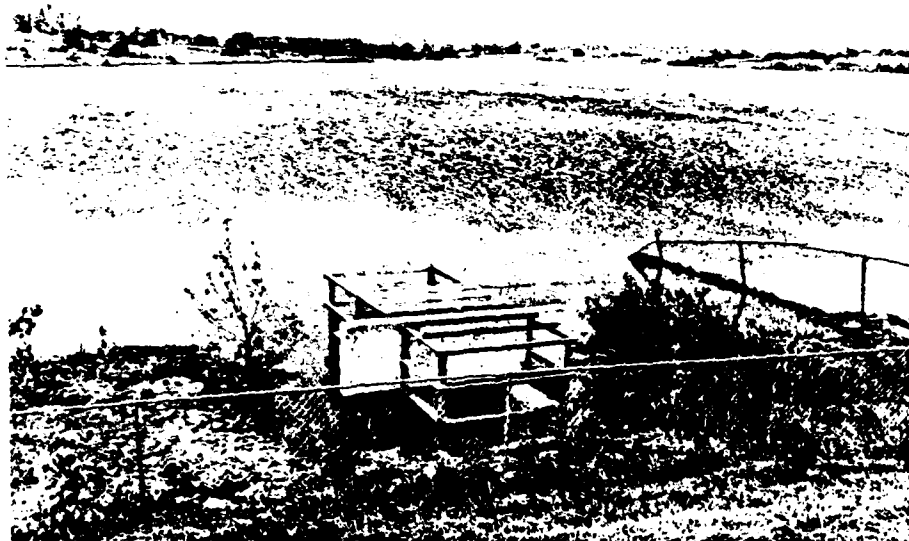
(1) Principal Spillway - There were no indications of spalling or deterioration of the principal spillway riser nor the concrete pipe outlet. The lake level was at the spillway crest elevation at the time of the inspection.

PHOTO NO. 6
PRINCIPAL SPILLWAY
FROM ABOUT
STA. 7+60

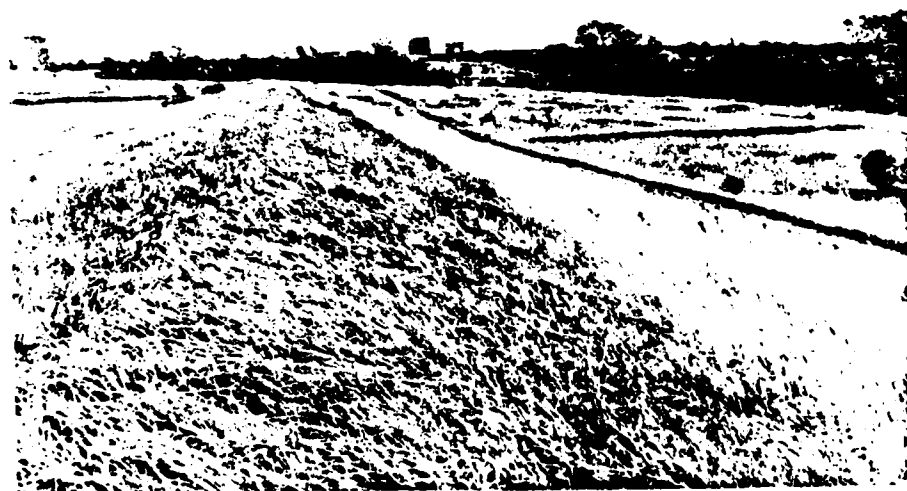
No cracks, slides, or abnormal deformations were observed in the embankment.

PHOTO NO. 10
DOWNSTREAM SLOPE
FROM STA. 3+00
TO EAST

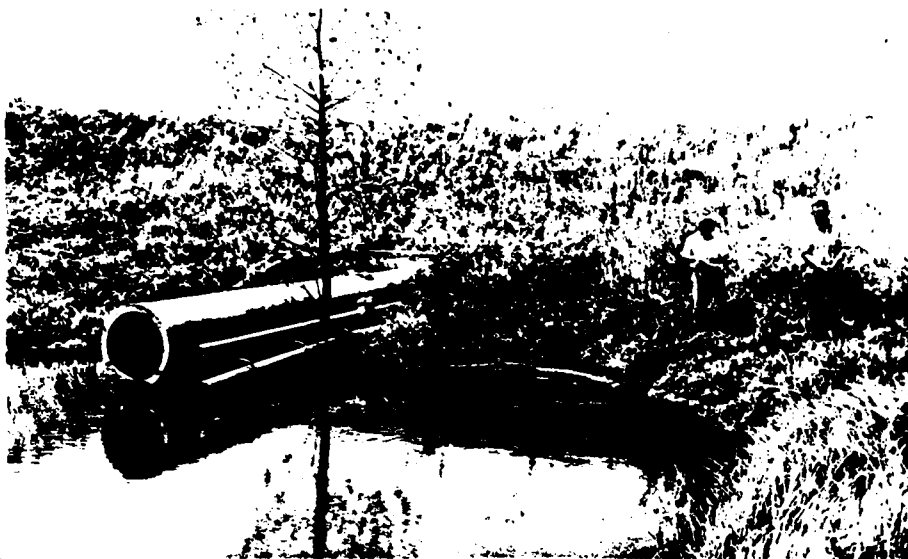
PHOTO NO. 11
LOOKING UPSTREAM
INTO STILLING
BASIN
